**UNITED STATES DEPARTMENT OF THE INTERIOR
FISH AND WILDLIFE SERVICE**

Special Scientific Report: Fisheries No. 65

A FISHWAY THAT SHAD ASCEND

By Gerald B. Collins
Fishery Biologist

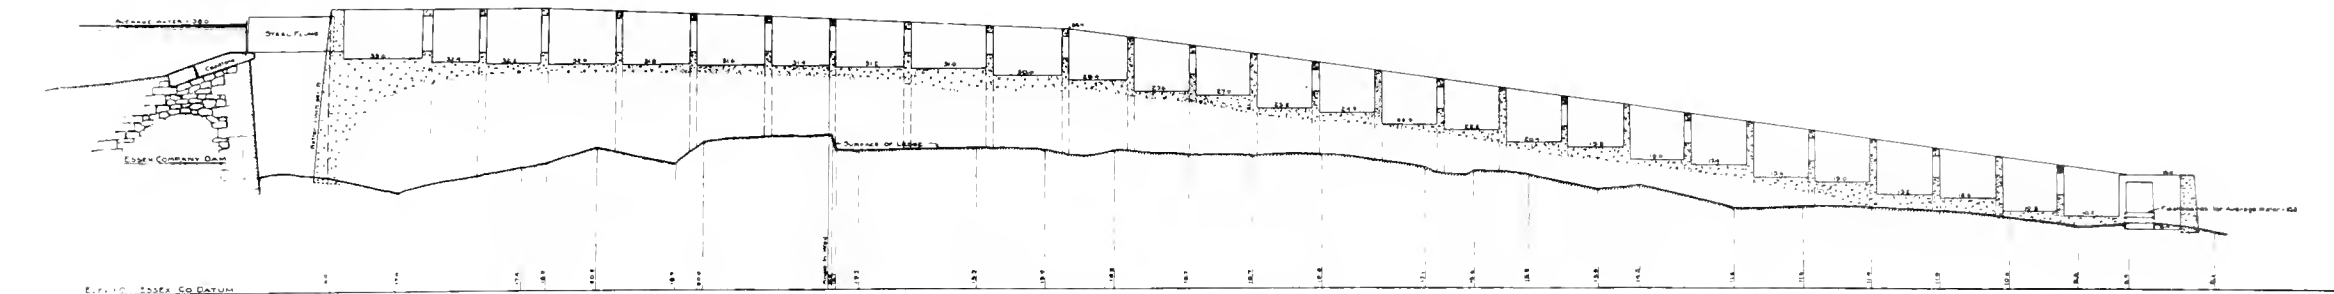
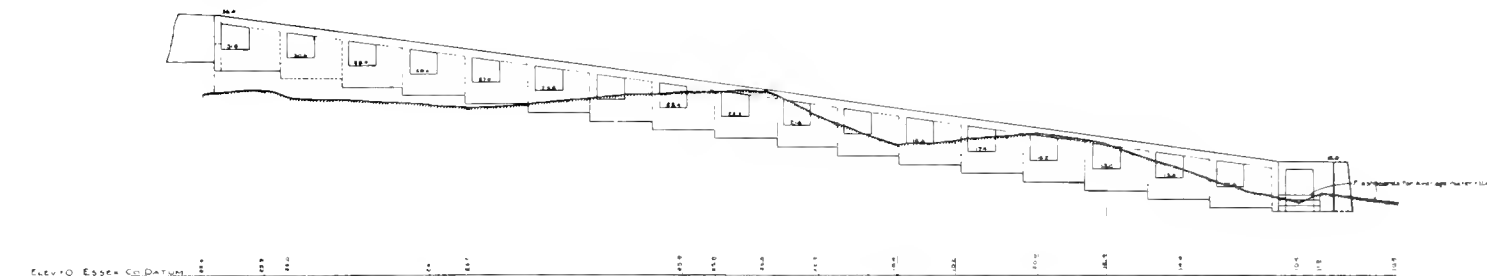
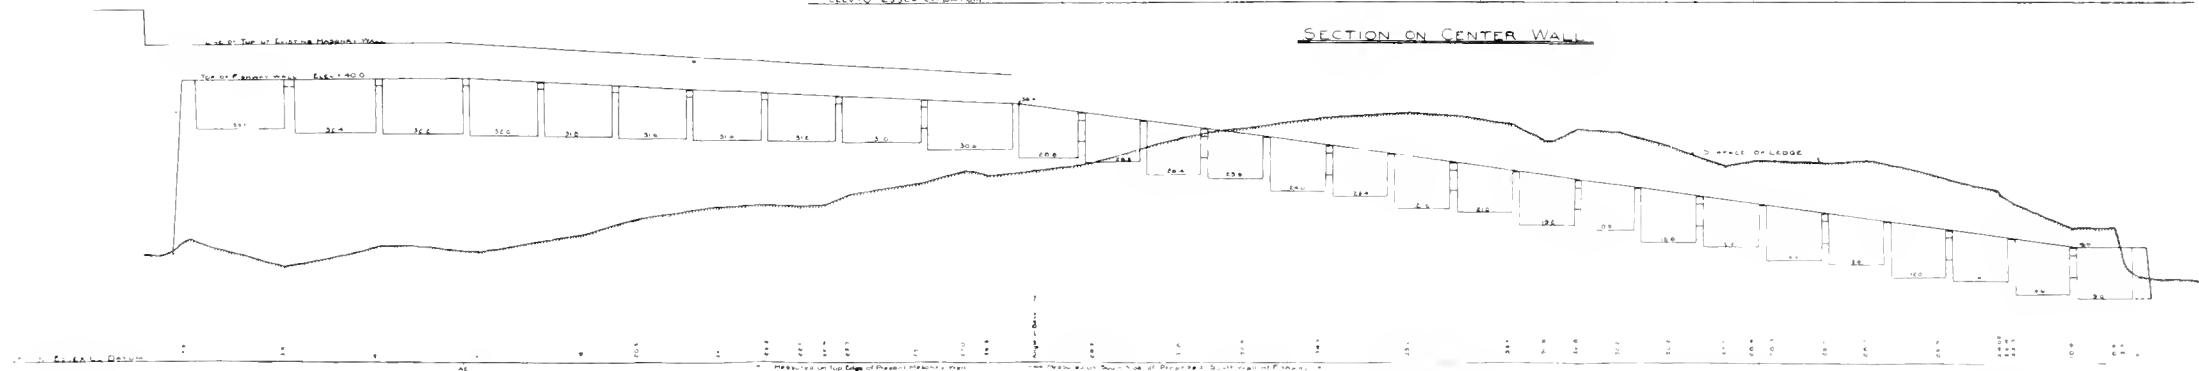
PROFILE OF NORTH WALL OF FISHWAY

SECTION ON CENTER WALL

PROFILE OF SOUTH WALL OF FISHWAY

Figure 2. -- Profile of Lawrence Fishway
Note lower flashboards. These proved difficult to maintain. (Modified in 1937).

In 1936, the fishway was severely damaged by flood waters. The following year major repairs were undertaken and at the same time several modifications were made. The most important of these changes was an alteration of the weirs. In crossing the original weirs which were 4 ft. wide (Figures 1 and 2), the deep-bodied shad sometimes had difficulty because of the relative shallowness of the water (from 2 in. to 6 in. in depth). Fish examined in the upper part of the fishway were frequently found to be badly scraped. To remedy this condition, in 1937 notched weirs were constructed on top of the original weirs. Each of the notches (Figure 11) is 2 ft. wide at the top, 1 ft. wide at the bottom and 1 ft. deep. The floor of each notch is sloped at an angle of 30°. The top of the notched weir is 1.5 ft. above the original weir. This modification not only resulted in a deeper flow across the weir but it raised the average depth of the water in the pools when the fishway was in operation from less than 3 ft. to more than 4 ft.

Because the shad did not enter the fishway under high tailwater conditions (tailwater elevations of 15 ft. above mean sea level or greater) in 1937 an opening was cut in the side of one of the lower pools (Figures 4 and 9) to allow the fish to enter the fishway without passing through the turbulent area (Figure 7) near the entrance.^{2/} Another change that was made in 1937 was the replacement of the adjustable plank weirs in the lower 3 pools ("flashboards" of Figure 2) with notched concrete weirs.

The characteristics of flow in the fishway entrance and in the lowest two pools ^{5/} were studied under a variety of tailwater conditions (Figures 13, 14, 15). Flow patterns made with both the original "flashboard" arrangement (Figure 2) and with the notched weirs installed in 1937 showed only minor differences because the weirs are flooded throughout most of the range of tailwater elevations at which shad enter the fishway. The flow in the lowest pool and through the entrance was remarkably uniform and lacking in turbulence. Velocities through the entrance ranged from a maximum of 2.6 ft/sec. at a tailwater elevation 11 ft. (above mean sea level) to less than 0.5 ft/sec. at a tailwater elevation of 14.5 ft. (above mean sea level). The large curved reinforcements on each side of the entrance created an area with lower velocities just outside the entrance (Figures 13, 14, 15).

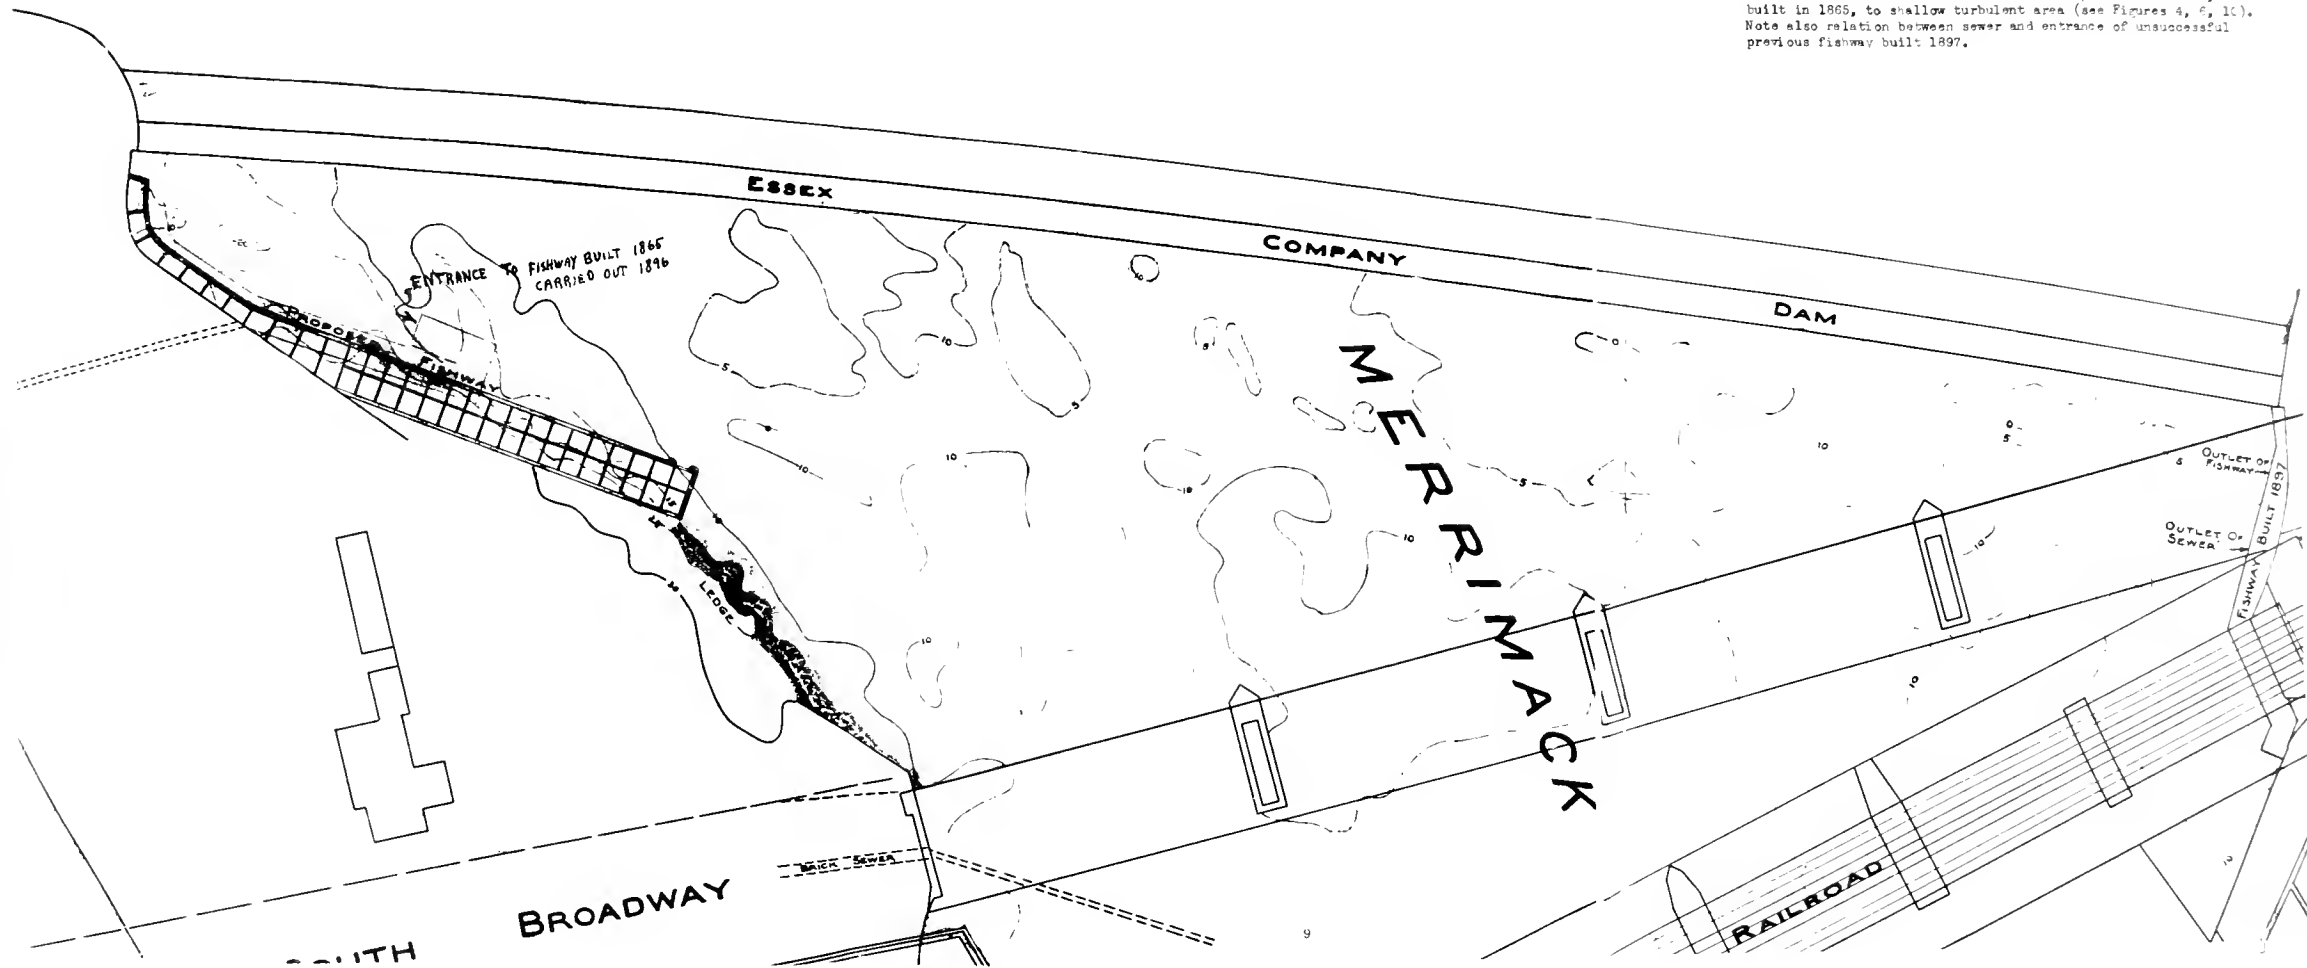
Figure 3. -- Location of Lawrence Fishway
 Note relation of fishway entrance to river channel and to shore.
 Note relation of entrance of unsuccessful previous fishway,
 built in 1865, to shallow turbulent area (see Figures 4, 6, 1C).
 Note also relation between sewer and entrance of unsuccessful
 previous fishway built 1897.

The entrance to the fishway is 4 ft. in width and is located at the edge of one of the main channels (Figure 3). In a normal year the new wood used for flashboards on the crest of the dam is placed on the north side of the dam. During the winter the weaker boards on the south side of the dam frequently become damaged by ice and are washed out so that in the spring the flow is concentrated in the channel next to the fishway entrance. Large curved reinforcements on each side of the entrance (Figure 1), probably designed to strengthen the fishway structure at the opening, may actually be responsible for a large measure of the fishway's success with shad.

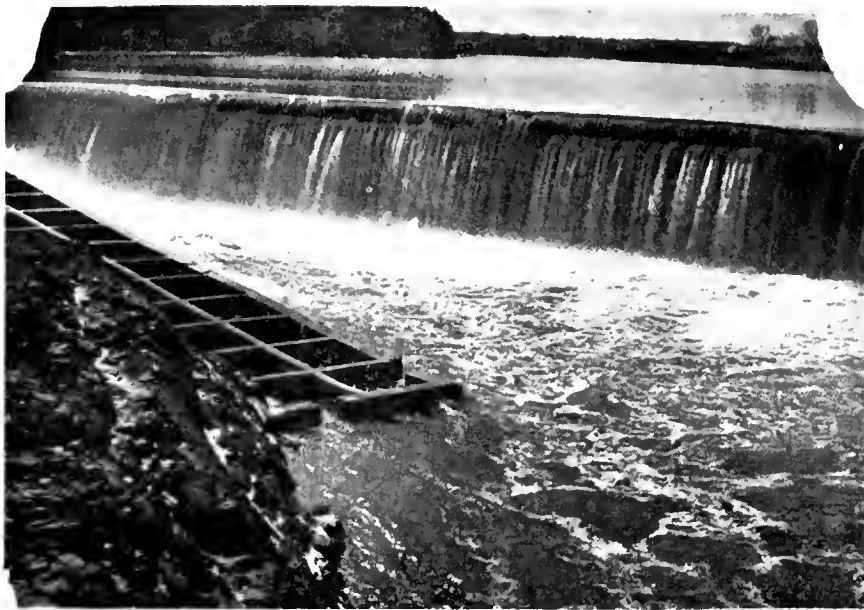
Figure 4.-- General View of Lawrence Fishway
 Tailwater Elevation 14.5 ft. (above mean sea level). This water level probably represents the maximum tailwater level under which shad enter the ladder. Water velocity through fishway entrance about 0.3 ft/sec. Note opening (3 ft. x 3 ft.) cut in side by second pool in 1937. There is no evidence of this opening ever being used.

The probable maximum water level at which shad enter is at a tailwater elevation of 14.5 ft. (above mean sea level). At this water level the velocity of the water through the entrance is reduced to about 0.3 ft./sec. and water flows through the opening in the wall of the second pool at about 1 ft./sec. Above this tailwater level the water in the vicinity of the fishway entrance becomes excessively turbulent (Figure 6).

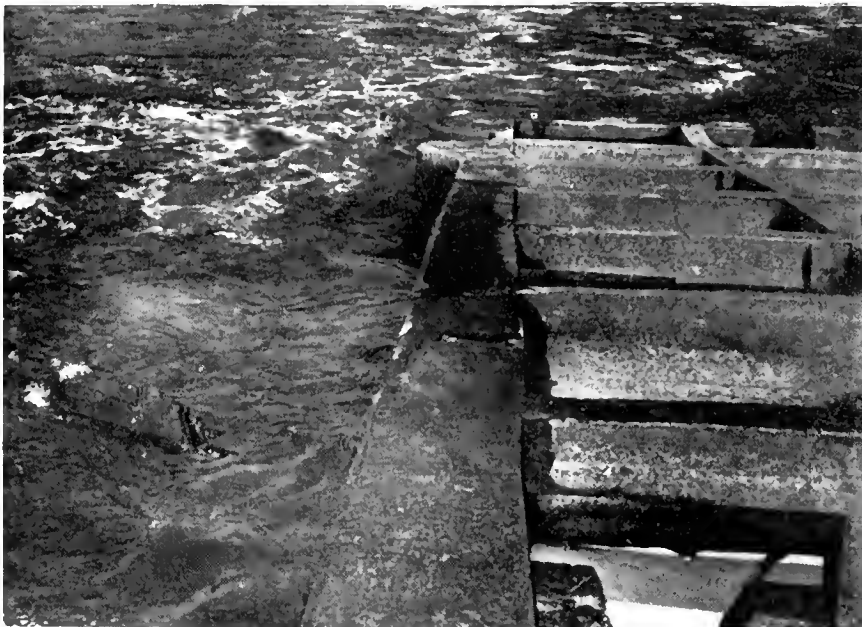
Figure 5.-- Water Conditions at Fishway Entrance
 Tailwater Elevation 14.5 ft. (above mean sea level). Note the large rock in the left foreground. The extreme turbulence of the water to the left of this rock can be seen in Figure 4 above.

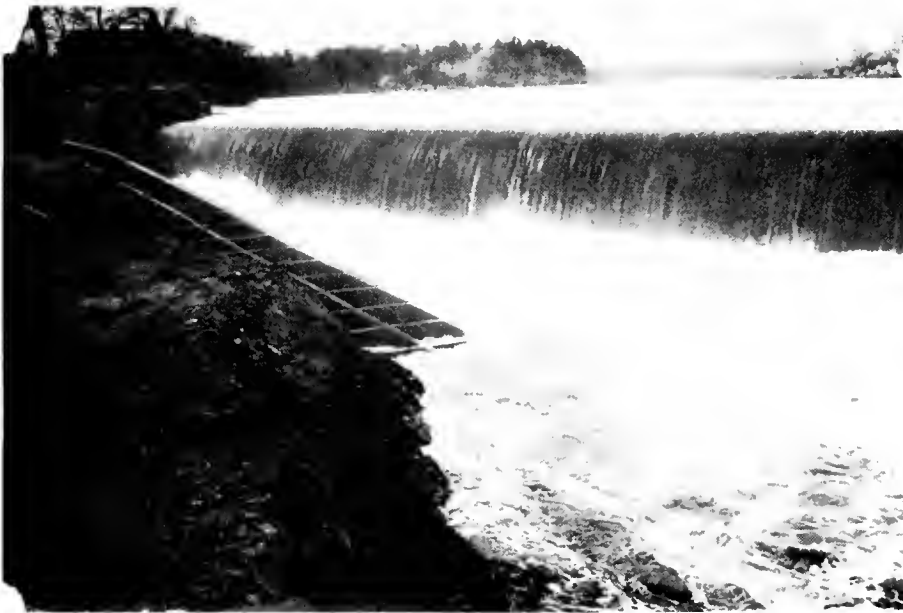
Figure 6.-- General View of Lawrence Fishway
Tailwater Elevation 17 ft. (above mean sea level) Note extreme turbulence. Shad do not approach the fishway under these water conditions.

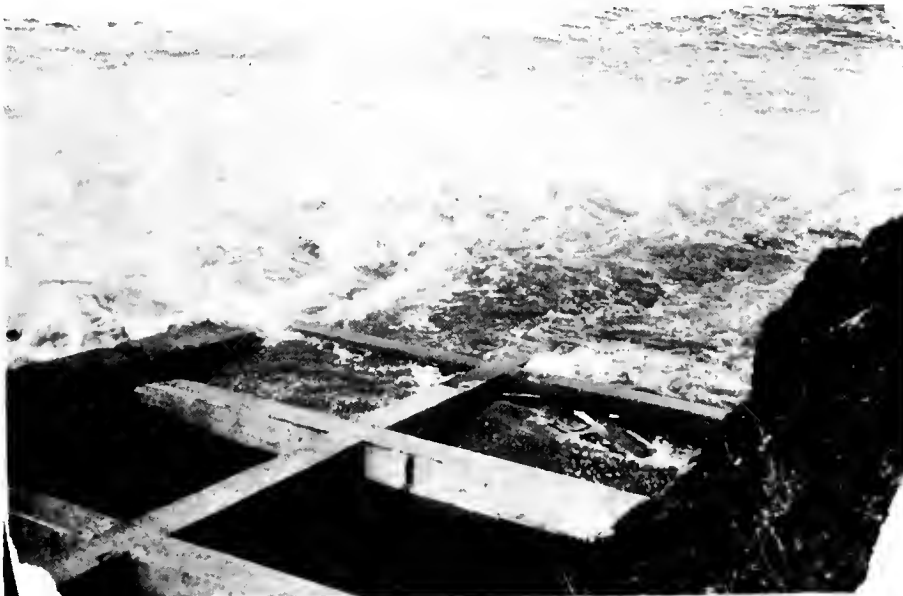
Figure 7.-- Flooded Fishway Entrance
Tailwater Elevation 17 ft. (above mean sea level).

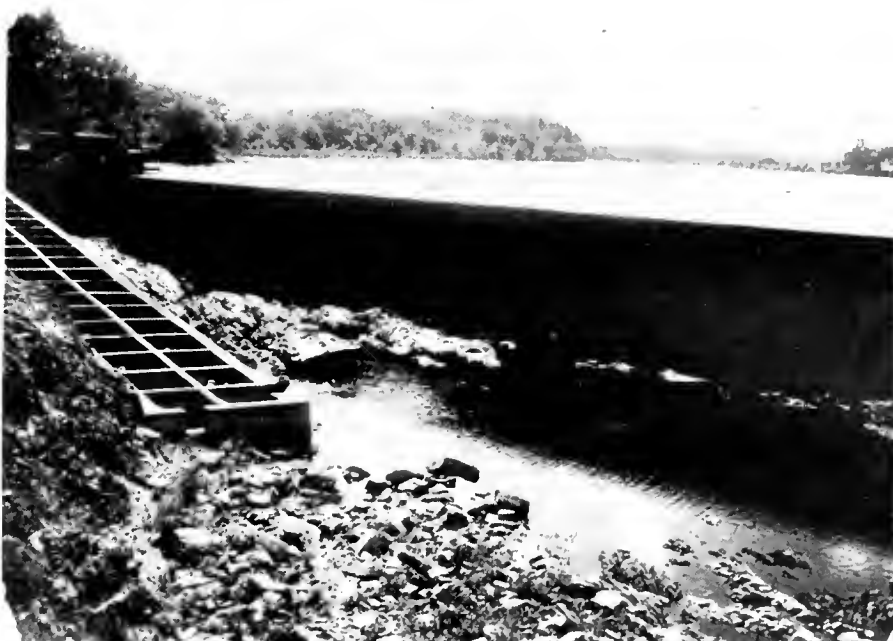
Figure 8.-- General View of Lawrence Fishway
Tailwater Elevation 7 ft. (above mean sea level) No water over spillway. Shad are unable to reach the fishway under these conditions.

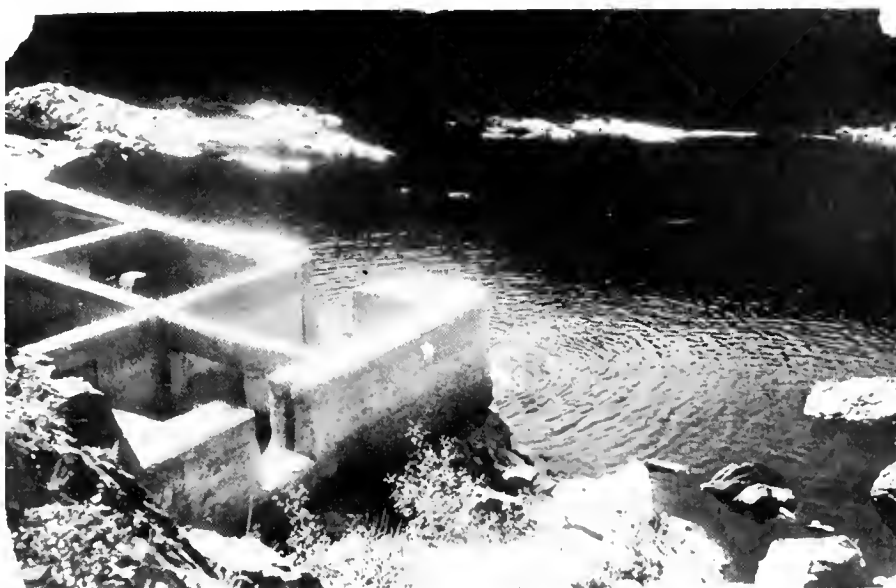
Figure 9.-- Close-up of Fishway Entrance
Tailwater Elevation 7 ft. (above mean sea level)

^{5/} The opening in the side of the second pool (Figure 9) was not made in the model. It is not involved at tailwater elevations of 13 ft. (above mean sea level) or lower and it has very little influence upon the pattern of flow until tailwater elevations exceed 13.5 ft. (above mean sea level). Its main effect is a reduction in the velocity of the flow through the fishway entrance.

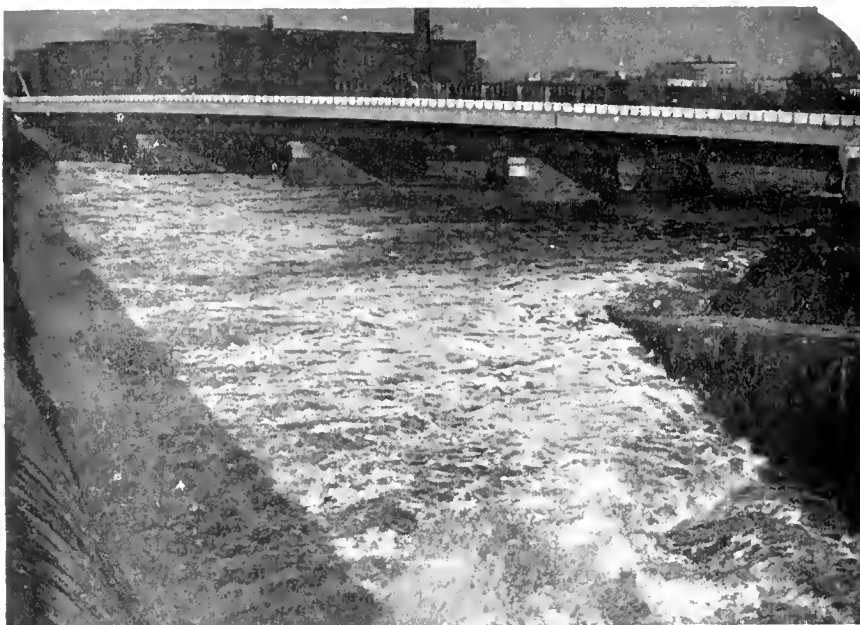
Figure 10. -- View of Lawrence Fishway Facing Downstream
Tailwater Elevation 17 ft. (above mean sea level).

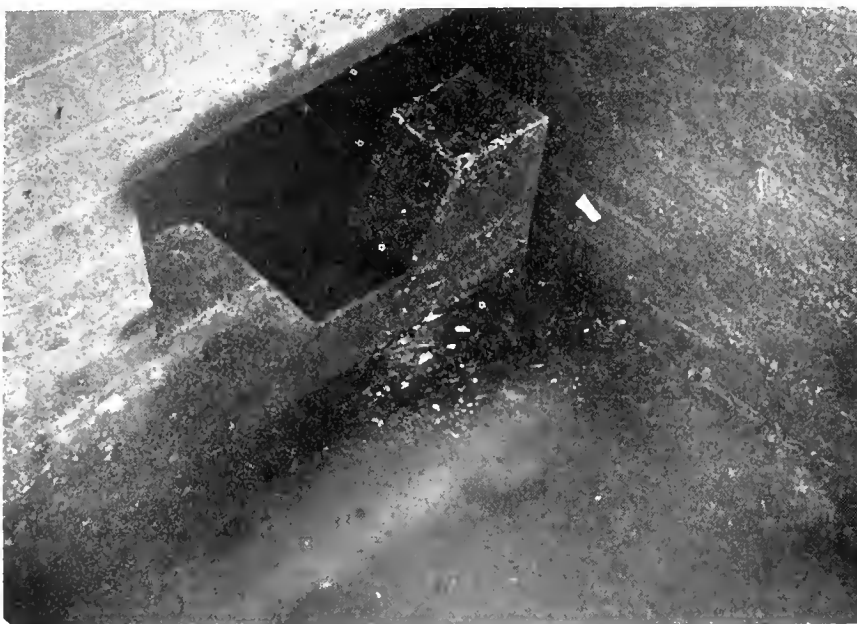
Figure 11. -- Notched Weir.
Note the unusual thickness of the weir and the sloping floor of the notch. The downstream edges of the notch have a 2-inch bevel.

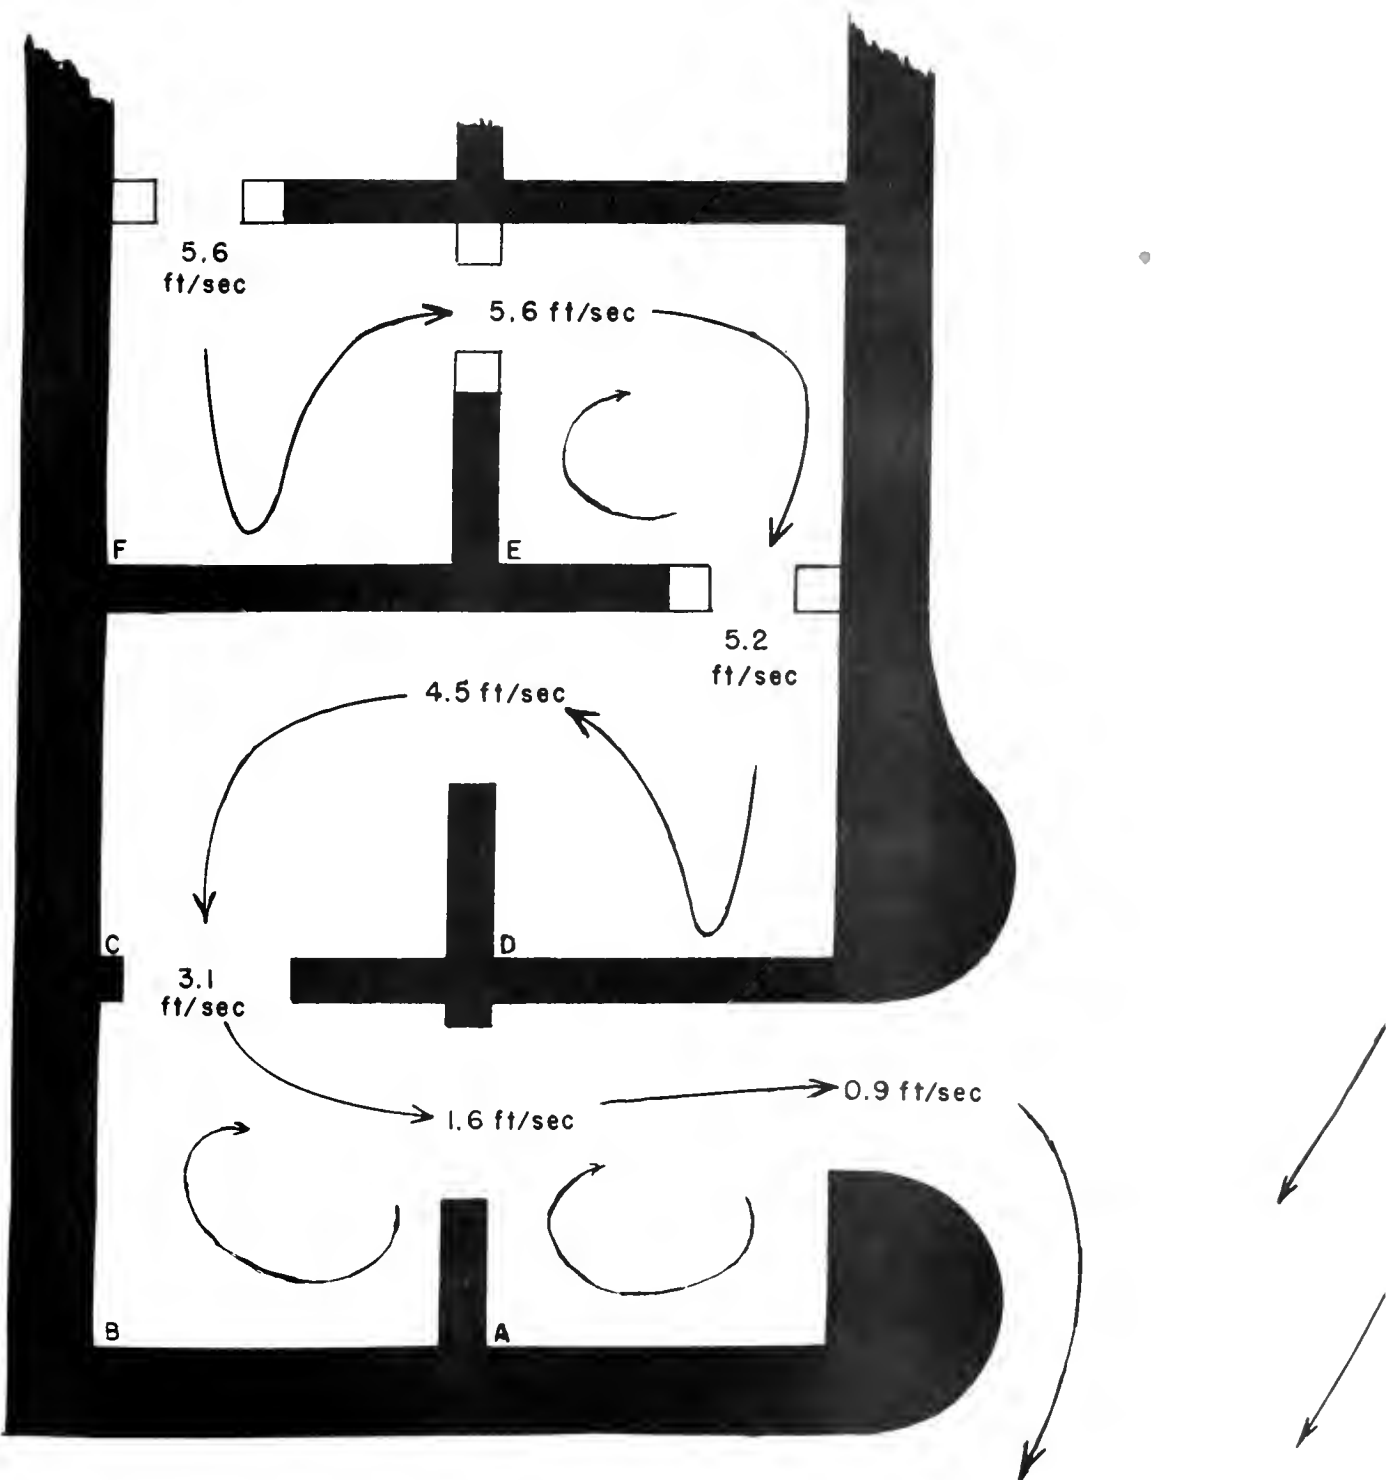
Figure 12.--Diagram of Flow Pattern in Lawrence Fishway
 Tailwater Elevation 13 ft. (above mean sea level). The velocities shown are the maximum velocities in the jet. These velocities exist for only a few inches since the jet dissipates rapidly. In pools E and F all velocities, other than in the jet, were less than 1.5 ft/sec. The arrows diagram the main flow, not surface currents. Note that the first 4 weirs are flooded. The almost 180° change in the direction of flow shown in pools D and F is an undesirable feature. It has been observed that the fish sometimes hit the wall at the turning point. Probably the low water velocities involved keep this from being a serious condition in the Lawrence Fishway.

A comparison was made of the flow patterns in the fishway pools with the two different types of weirs, the original wide weir and the notched weir with its sloping floor. The direction of the main flow (Figure 12) was approximately the same with both types of weirs, although the flow from the notched weir was much more concentrated. The greater depths created by the addition of notched weirs resulted generally in lower velocities and reduced turbulence, particularly in the lower areas of the pools. However, the maximum velocities in the jet produced by the notched weir were about 0.8 ft/sec. higher than the maximum velocities produced by the wide weir. Thus, with the notched weir, there was a much sharper contrast between the velocity of the water in the jet and the velocity of the rest of the water in the pool. With the broad weir and the shallower depth, velocities throughout the pool were more uniform. The condition at the approximately 180° change in the direction of flow in certain pools (Figure 12) is probably accentuated by the concentrated flow from the notched weirs.

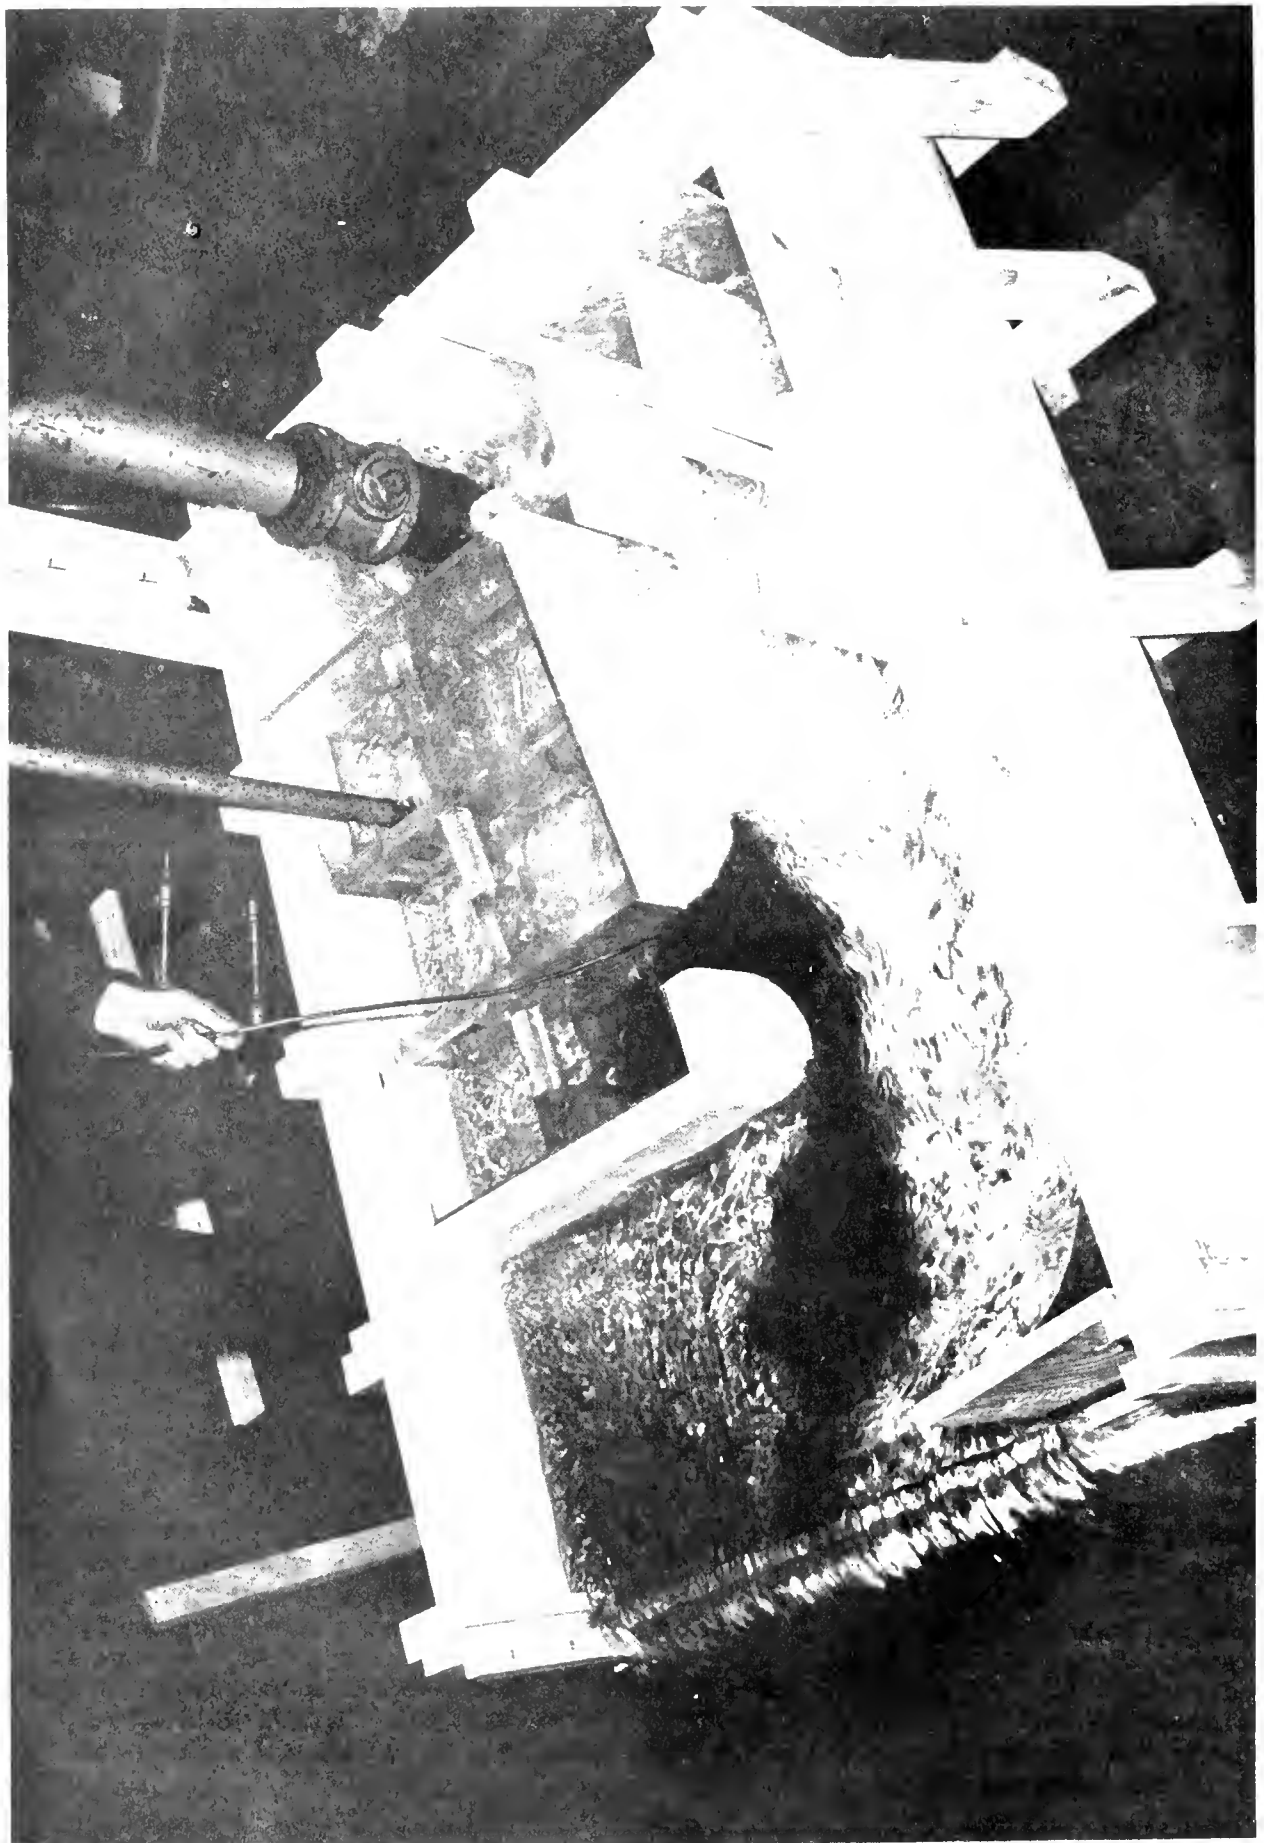
Figure 13. - General View of Fishway Model - (Alden Hydraulic Laboratory)
Tailwater Elevation 13ft. (Above mean sea level) The optimum conditions for entrance of shad into the fishway
are probably at this water level. Note area of reduced velocities at fishway entrance (black dye).

In order to examine in detail the characteristics of flow in the Lawrence fishway under varied water conditions, a plastic model of the lower six pools (Figure 13) was constructed and installed at the Alden Hydraulic Laboratory, Worcester Polytechnic Institute. The model was built according to the original plans (Figures 1 and 2) with removable inserts for the later modifications. Patterns of flow were studied by the addition of dye to the water.

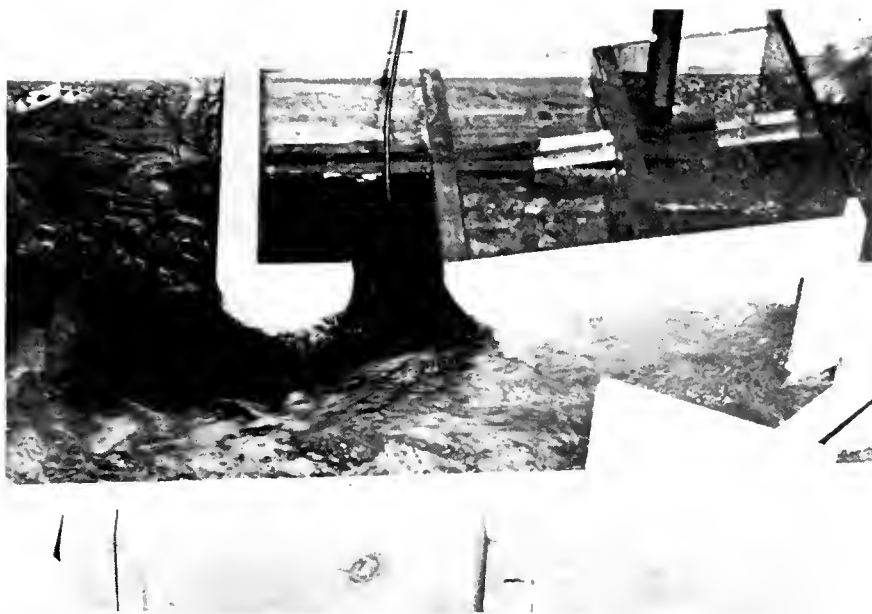
Figure 14.-- Entrance to Fishway (Model)
Tailwater Elevation 15 ft. (above mean sea level) Note flooding of weirs.

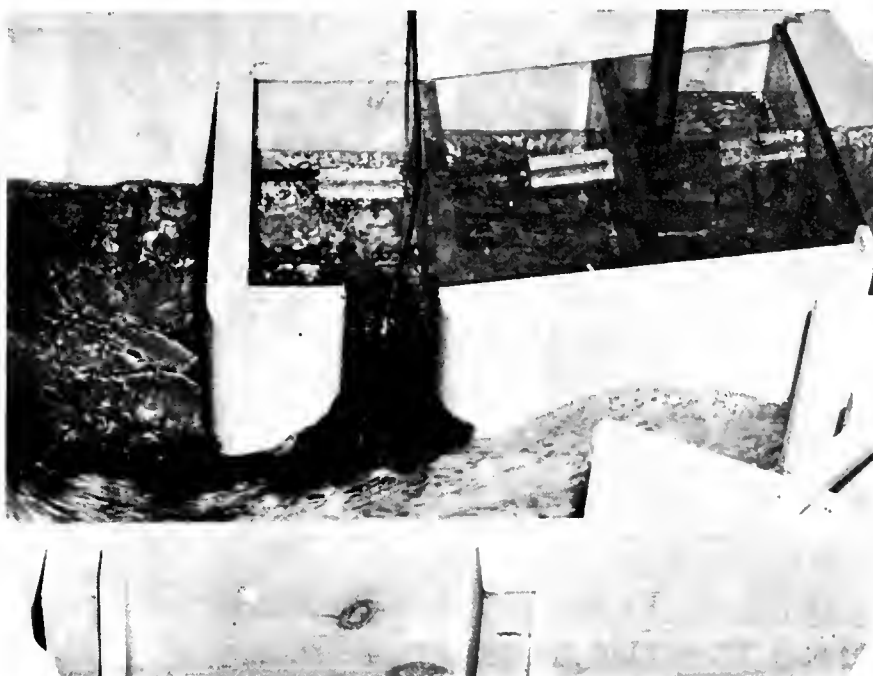
Figure 15.-- Entrance to Fishway (Model)
Tailwater Elevation 11 ft. (above mean sea level) This water level is probably close to the minimum tailwater level for entrance of shad into the fishway. Note that the first weir is flooded.

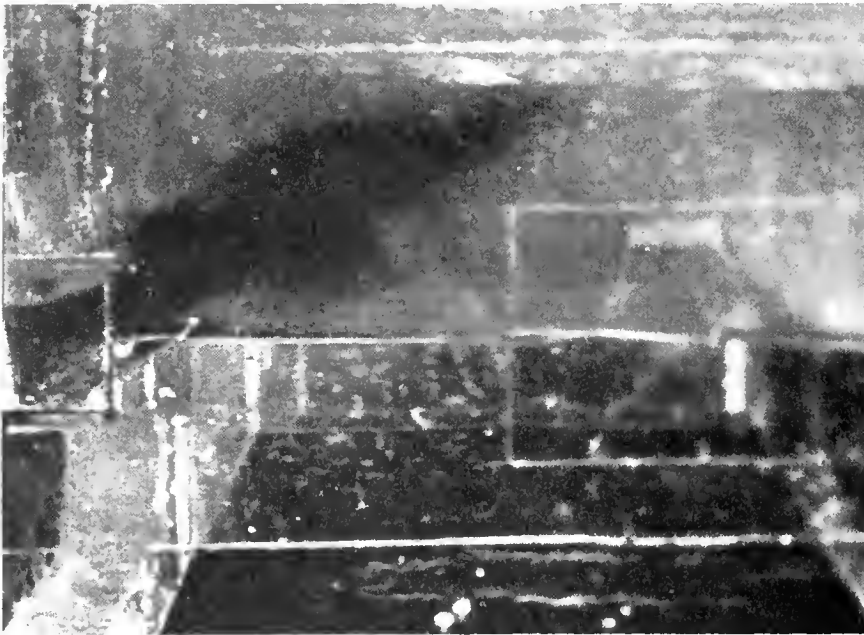
Figure 16.-- Jet from Notched Weir
(Model - Alden Hydraulic Laboratory) End view of pool E (see diagram Figure 12) of model.
